A method to detect sewer lateral defects – including laterals not currently sources of infiltration

Sewer Lateral Electro Scan Field Verification Pilot (INFR4R12)

Executive Summary

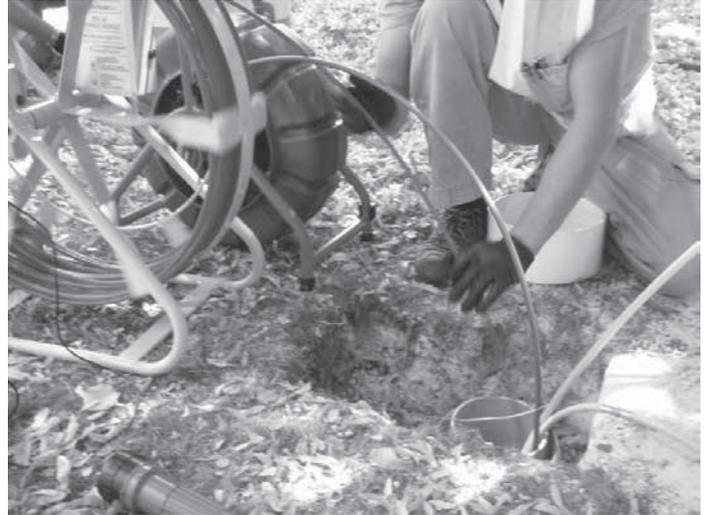
A lateral being tested with Electro Scan.
